# STRUCTURAL ENGINEERING INVESTIGATION & REPAIR RECOMMENDATION

**IFC SUBMITTAL  
14 FEBRUARY 2019**

**U.S. EMBASSY  
VIENTIANE, LAOS**

STRUCTURAL  
ENGINEERING  
INVESTIGATION  
& REPAIR

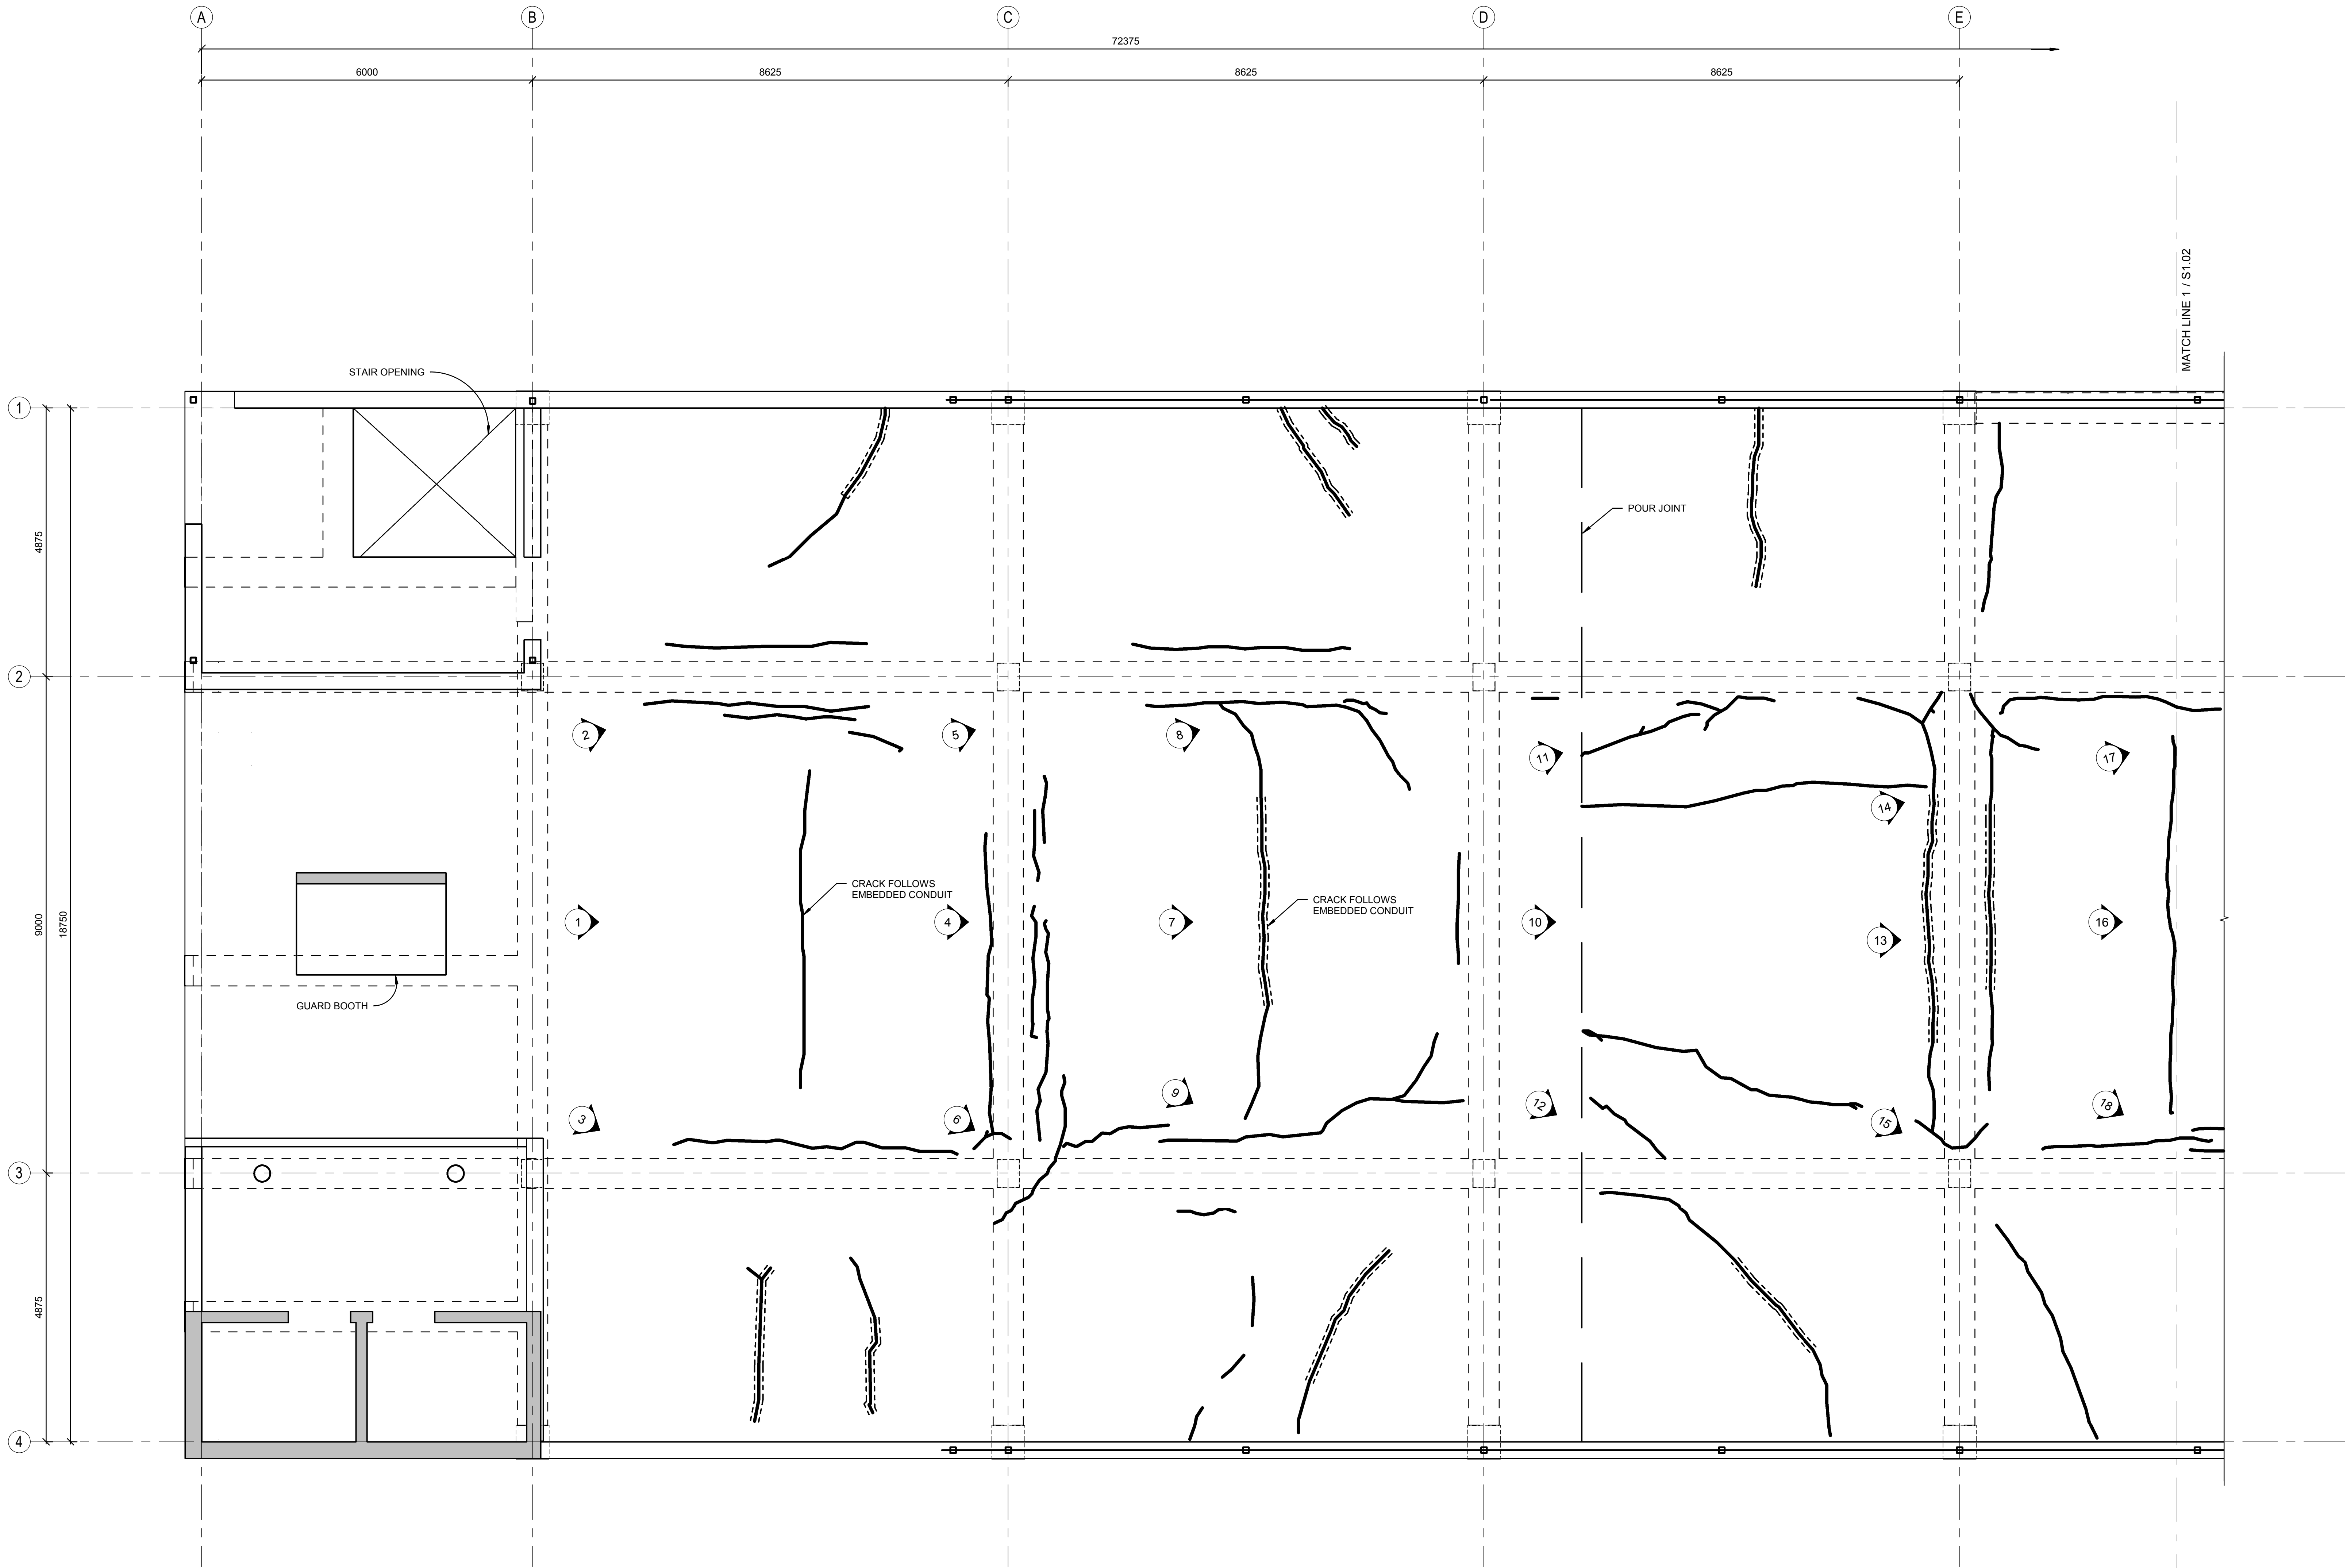
1 TOP OF SLAB CRACK MAP - SOUTH  
S1.01 1:50

NOTE:  
CRACK WIDTHS LESS THAN 0.51mm (0.02") ARE NOT SHOWN.

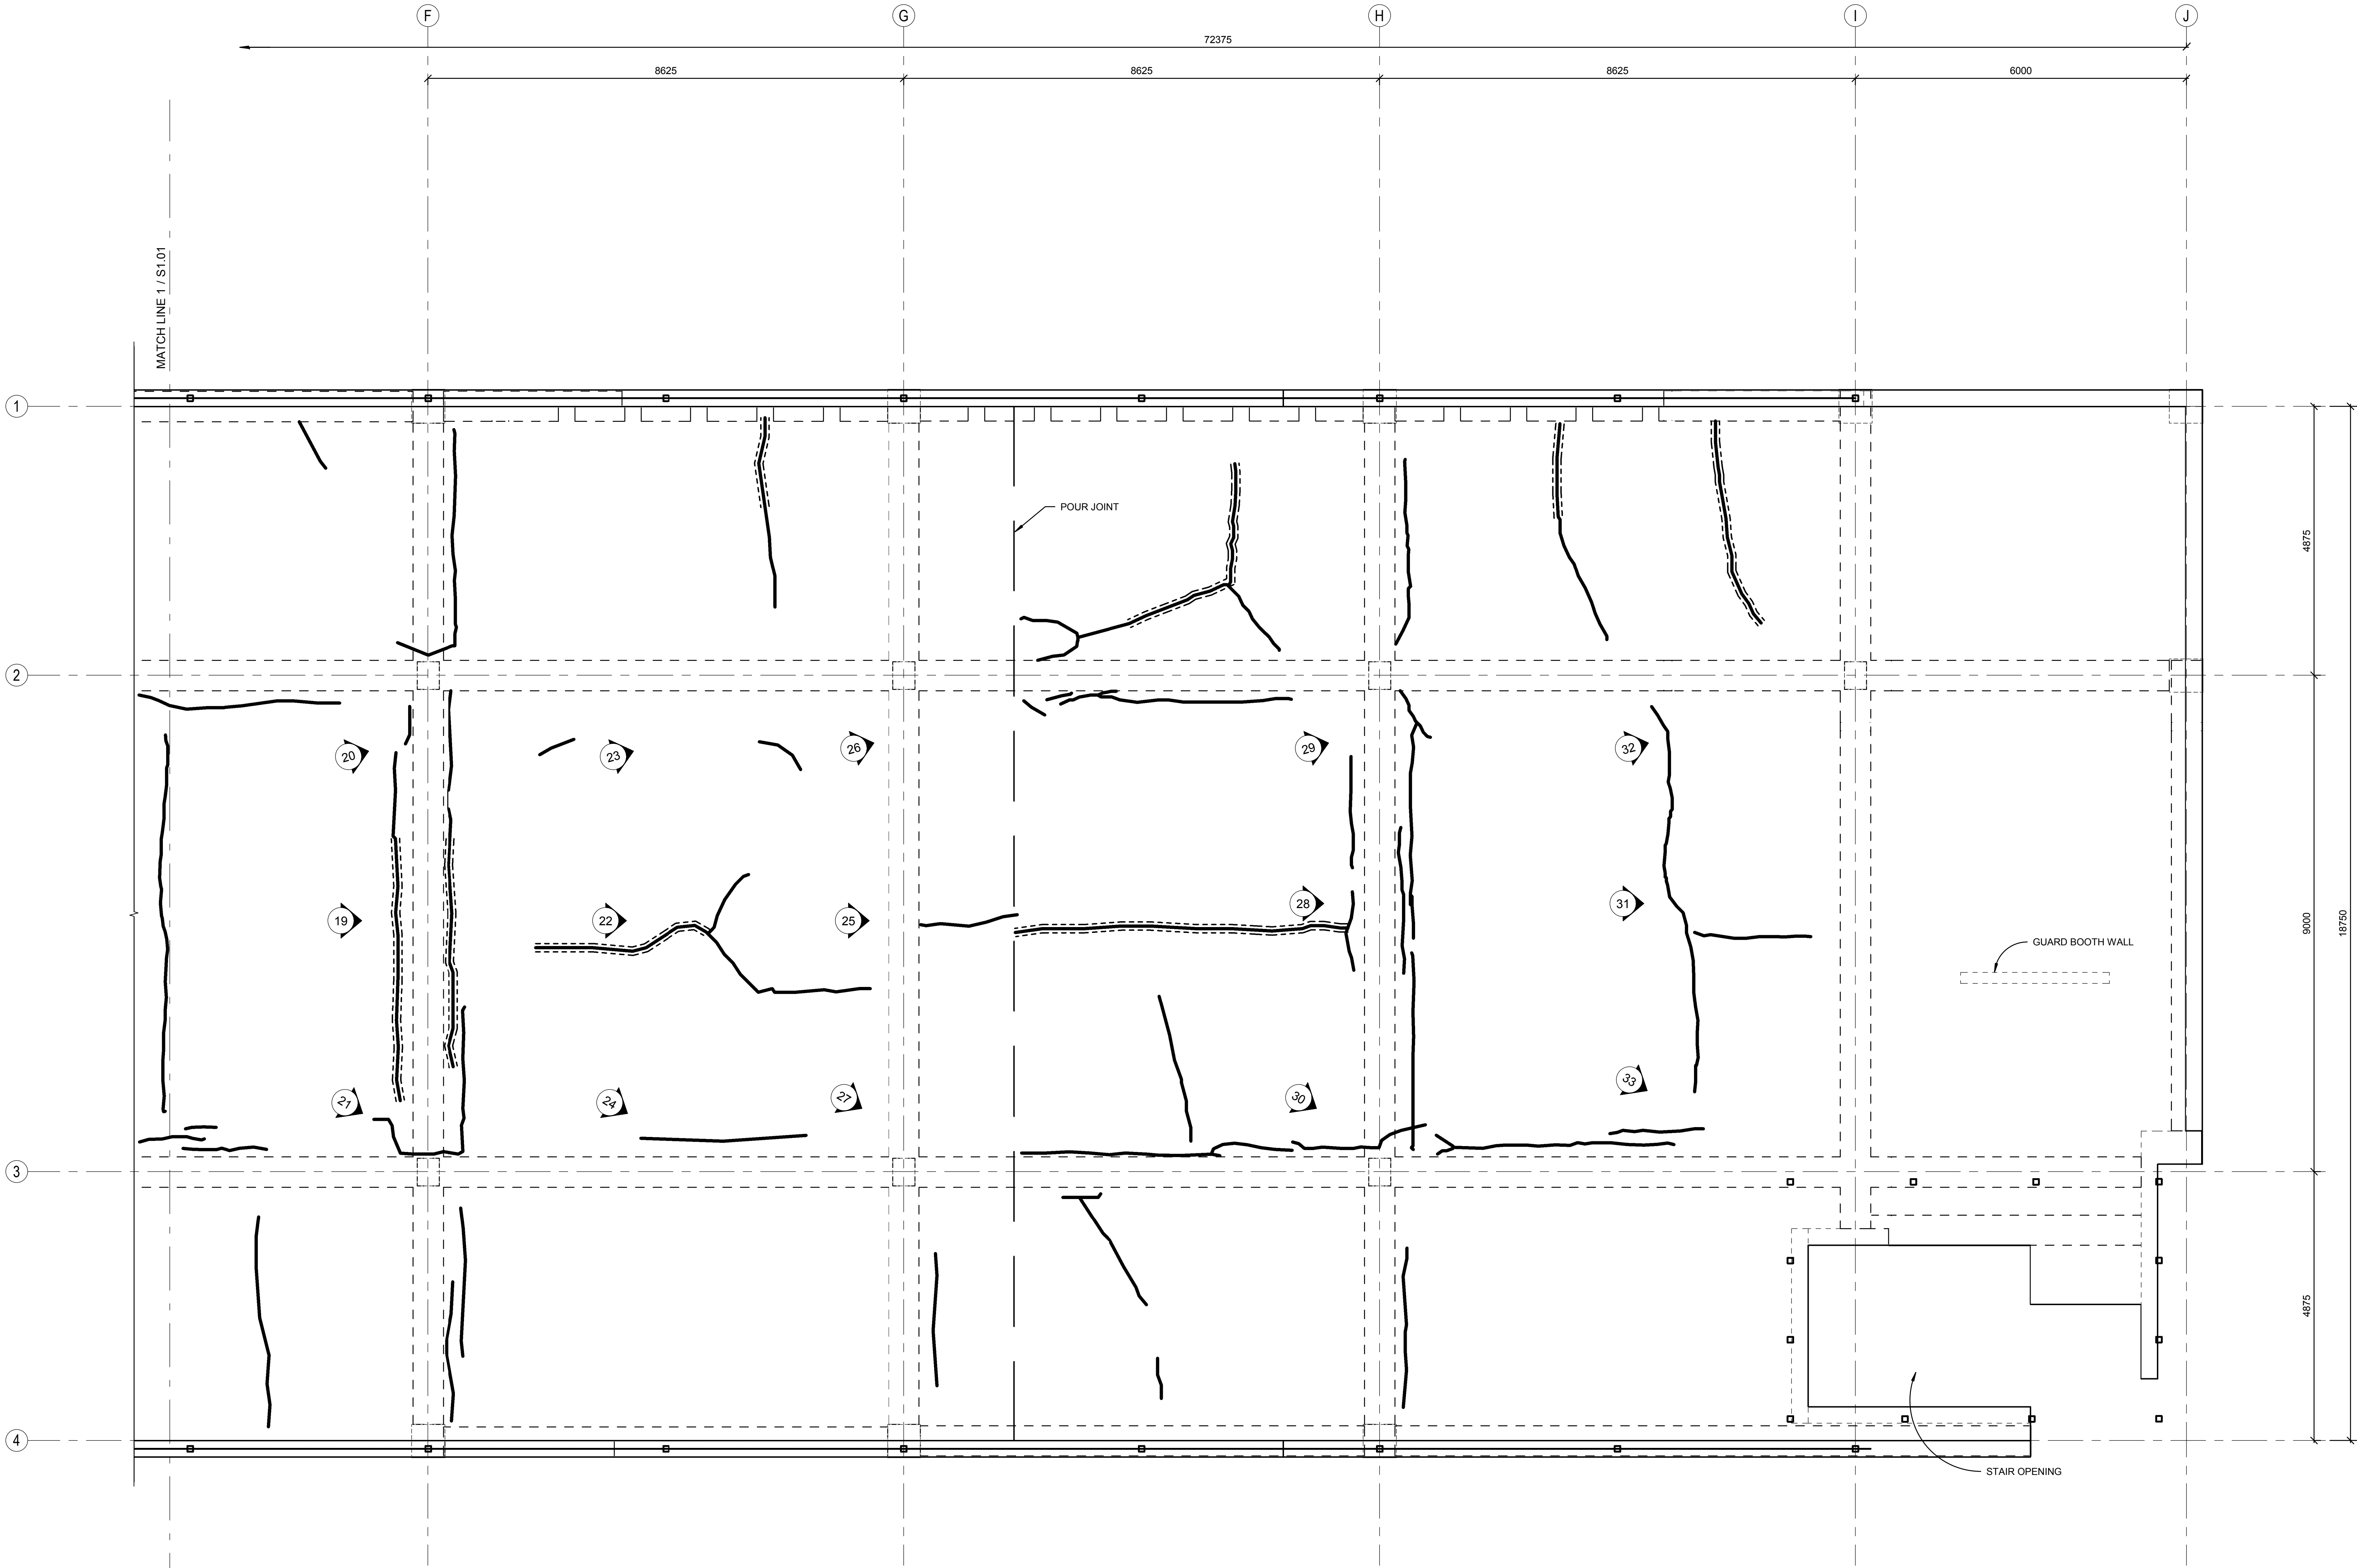
1 TOP OF SLAB CRACK MAP - NORTH  
S1.02 1:50

NOTE:  
CRACK WIDTHS LESS THAN 0.51mm (0.02") ARE NOT SHOWN.

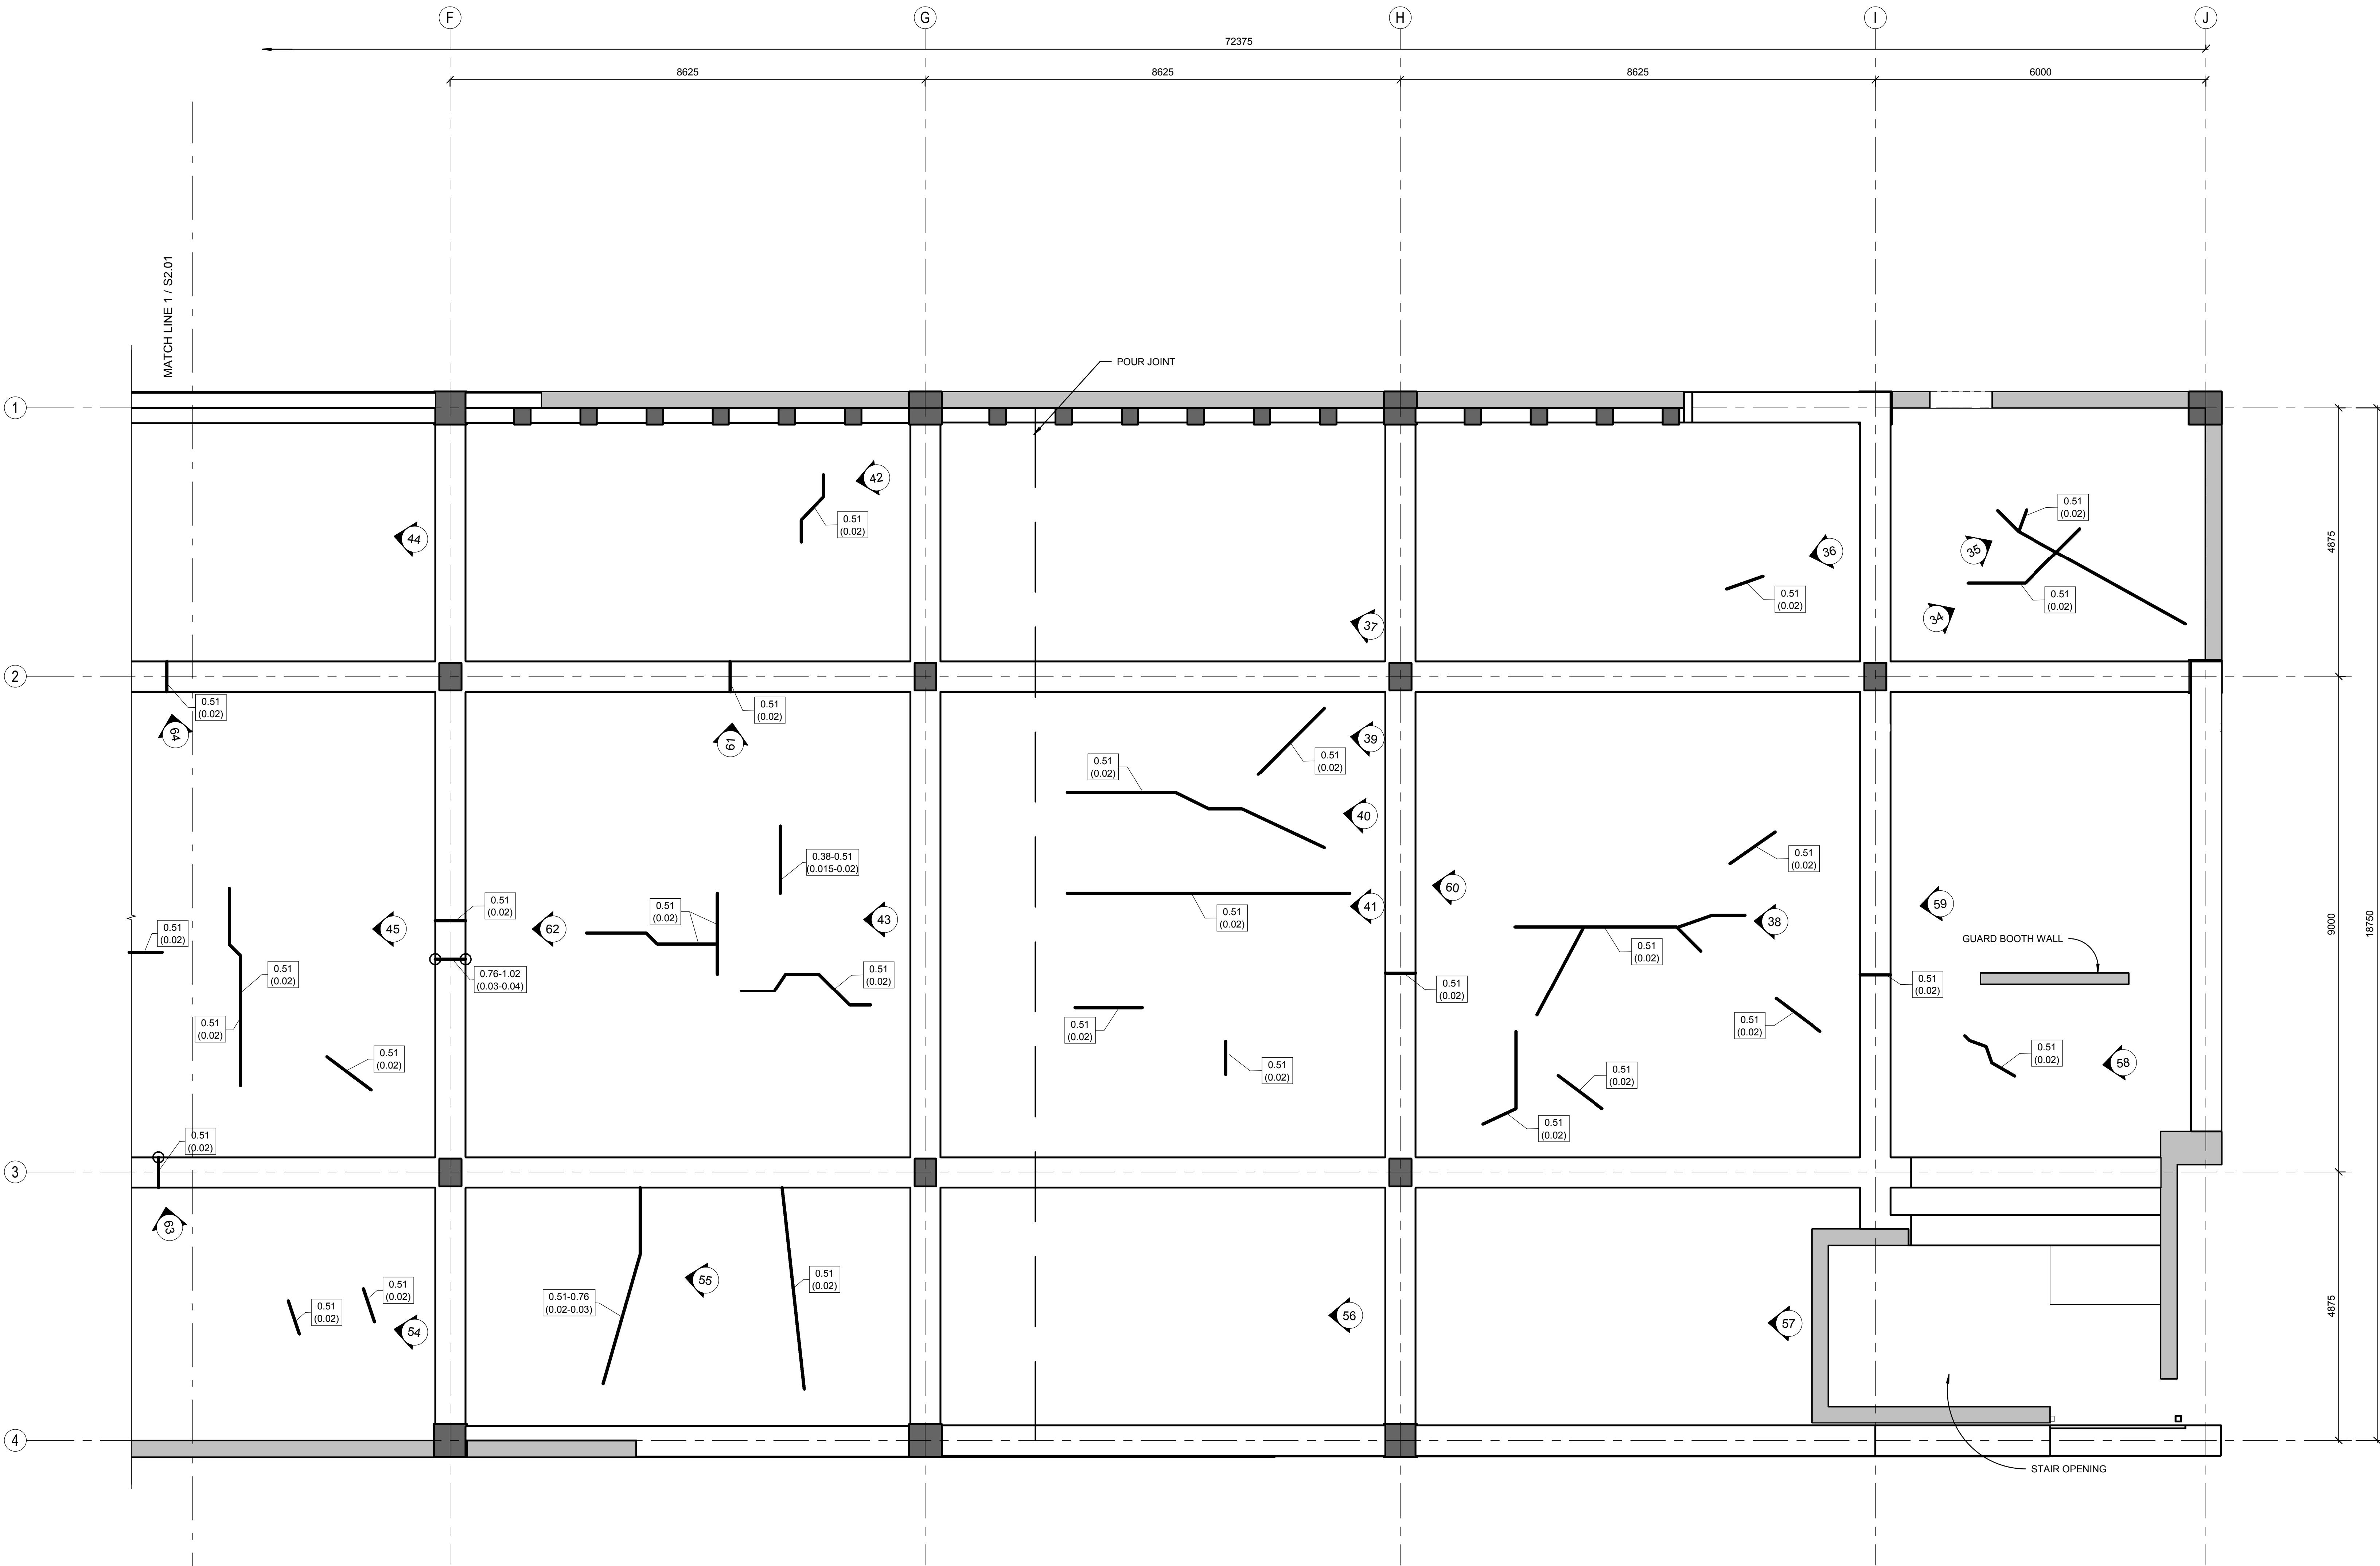
1 BOTTOM OF SLAB AND BEAM CRACK MAP - NORTH  
S2.02 1:50

NOTE:  
CRACK WIDTHS LESS THAN 0.51mm (0.02") ARE NOT SHOWN.
